Stormwater Pond Assessment Township of West Lincoln

August 12th, 2024

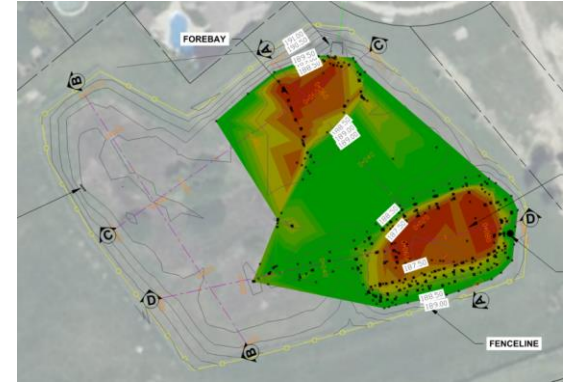
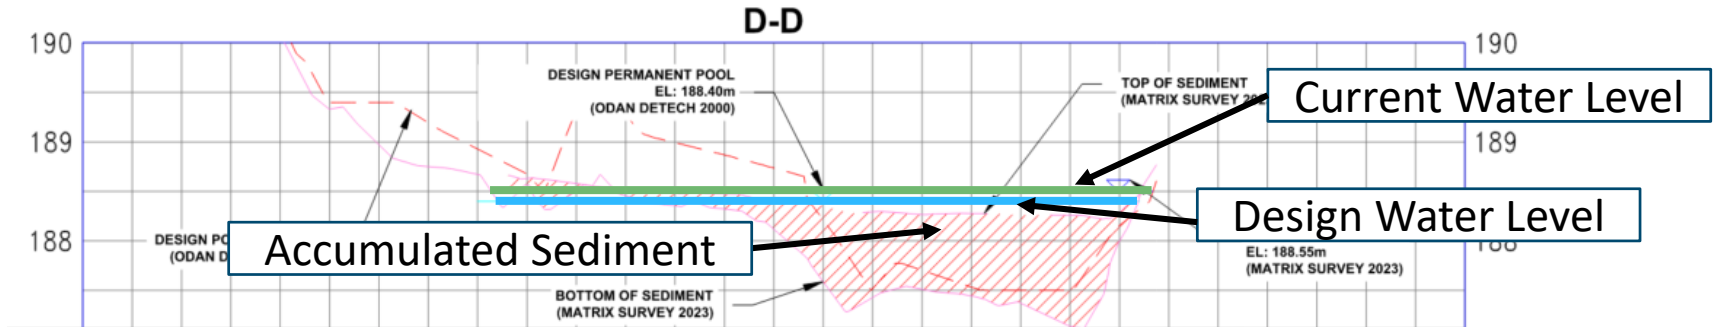
Hornak SWMP

1,022 m³ of sediment

Locate and assess outlet structure during construction.
Consider replacing rip rap jacket if filled with sediment.

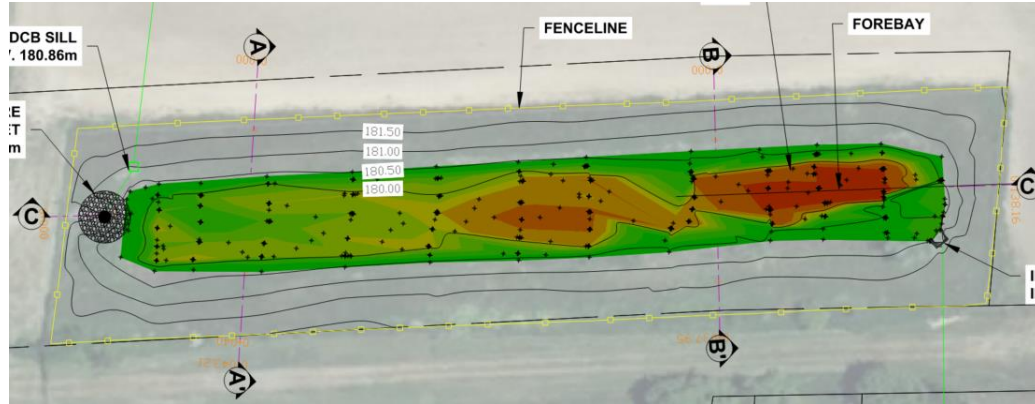
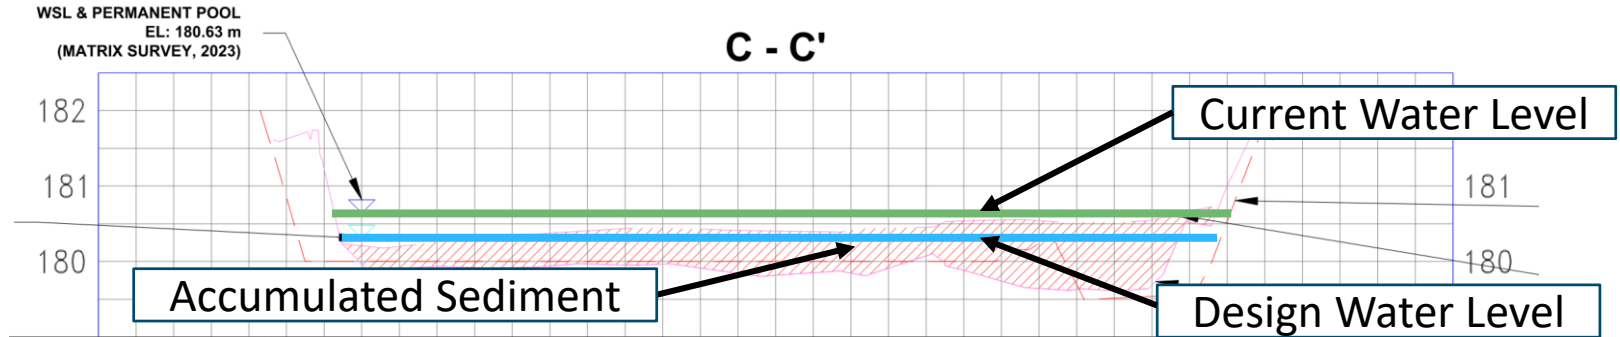
Townline SWMP

613 m³ of sediment

Clear outlet of
sediment and
vegetation

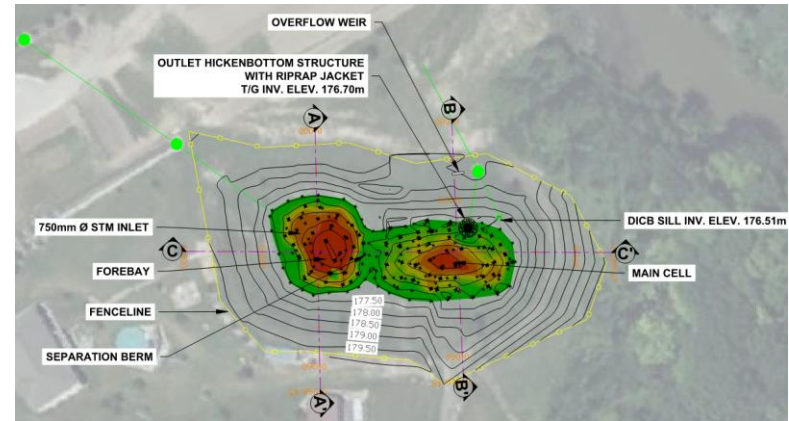
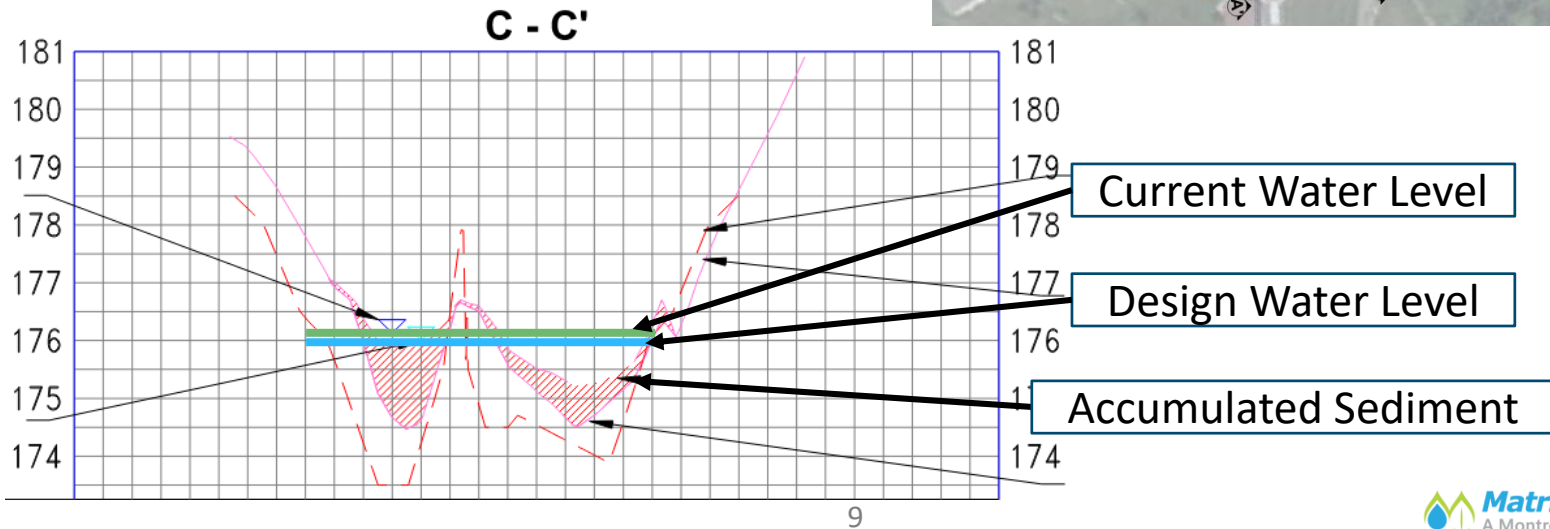
Attema SWMP

437 m³ of sediment

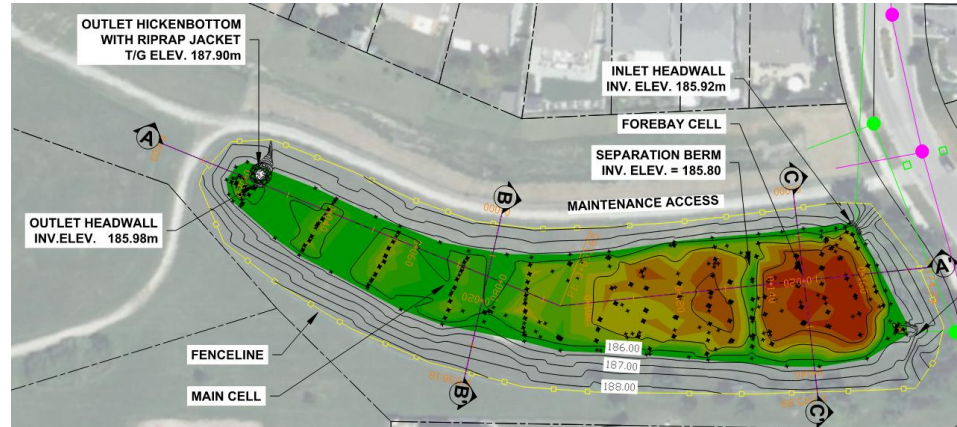
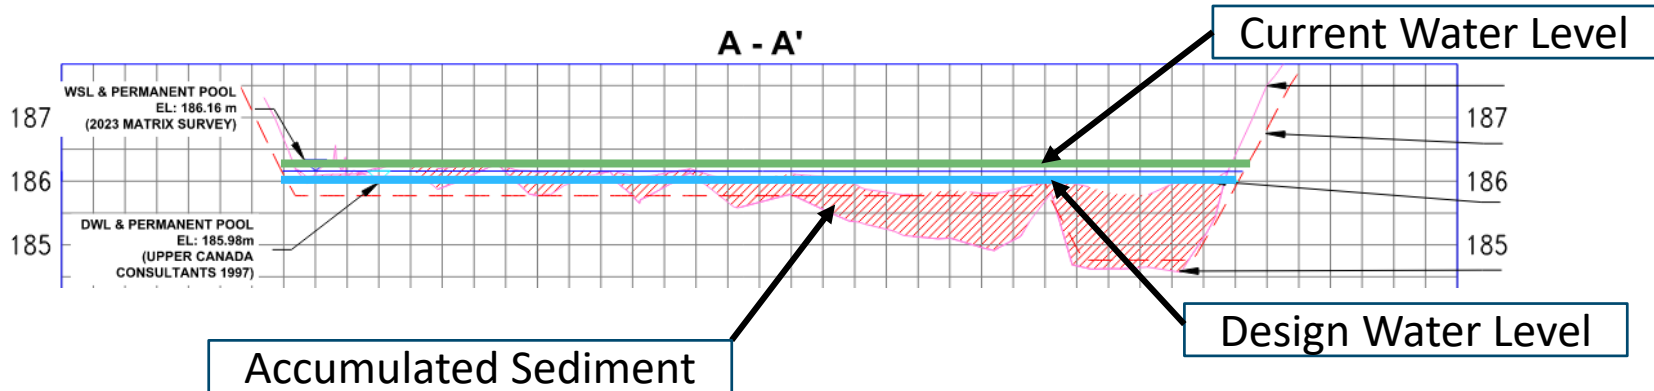
Oakdale SWMP

1,413 m³ of sediment

Remove sediment and vegetation from outlet HW

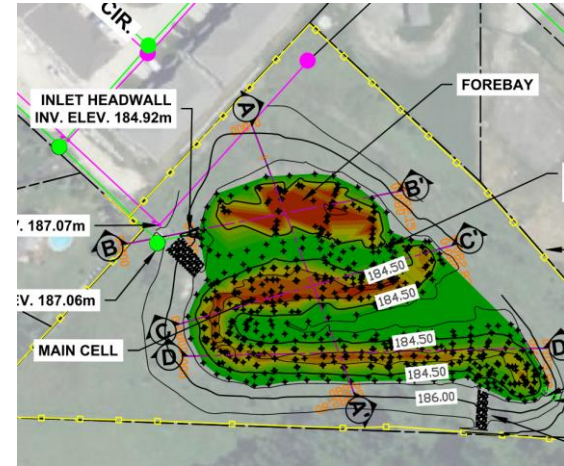
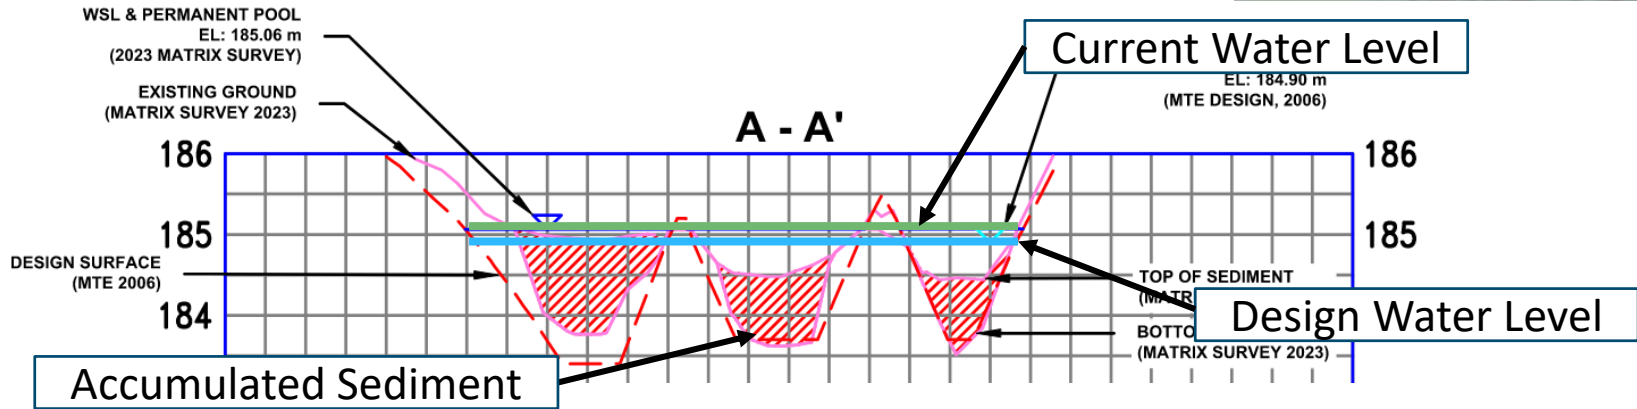
Streamside SWMP

1,672 m³ of sediment

Dredge forebay to meet design depth

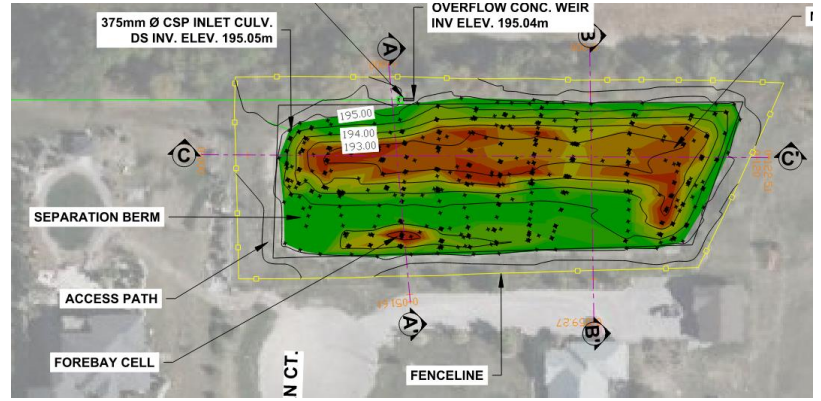
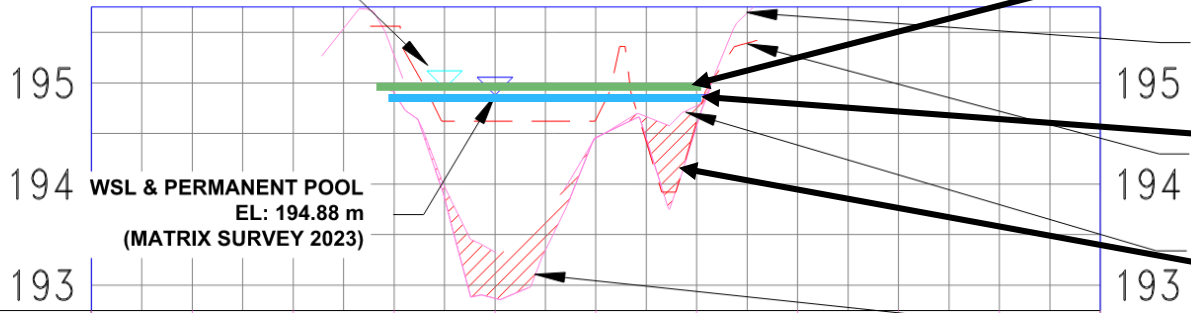
Sheridan SWMP

883 m³ of sediment

DWL & PERMANENT POOL
EL: 194.94 m
(UPPER CANADA
CONSULTANTS 2009)

WSL & PERMANENT POOL
EL: 194.88 m
(MATRIX SURVEY 2023)
