# Pavement Management System & Bridge Appraisal Status Report

Operations Committee

May 2025

### 2023 Structure Inspection Program - Rehabilitation/Replacement Needs

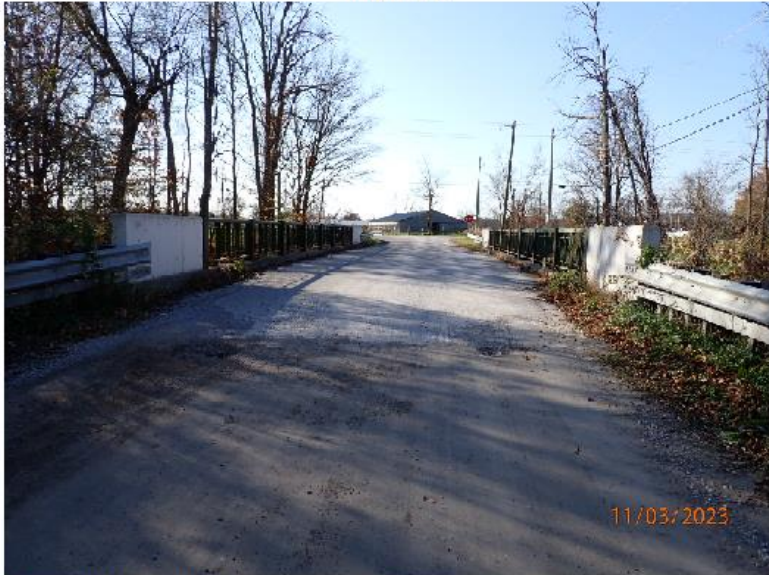
Photograph No. 1: 0362: Roadway over the structure looking south.

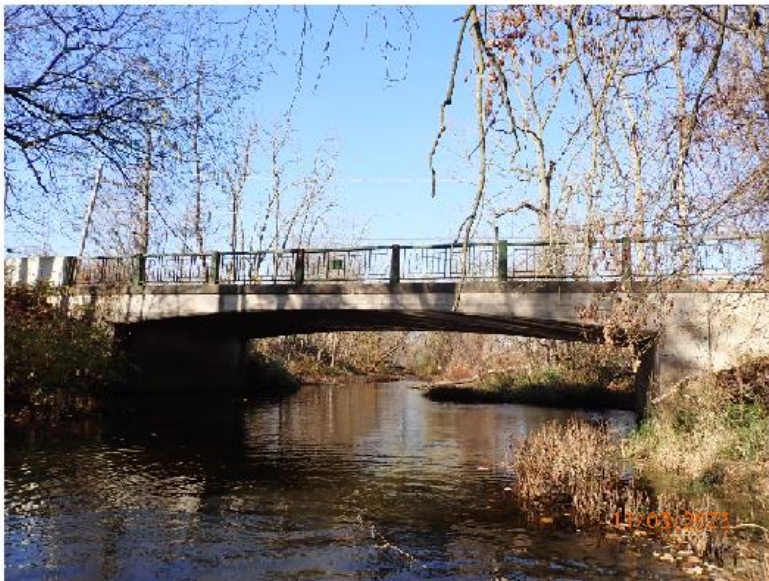
Photograph No. 2: 0433: East elevation.

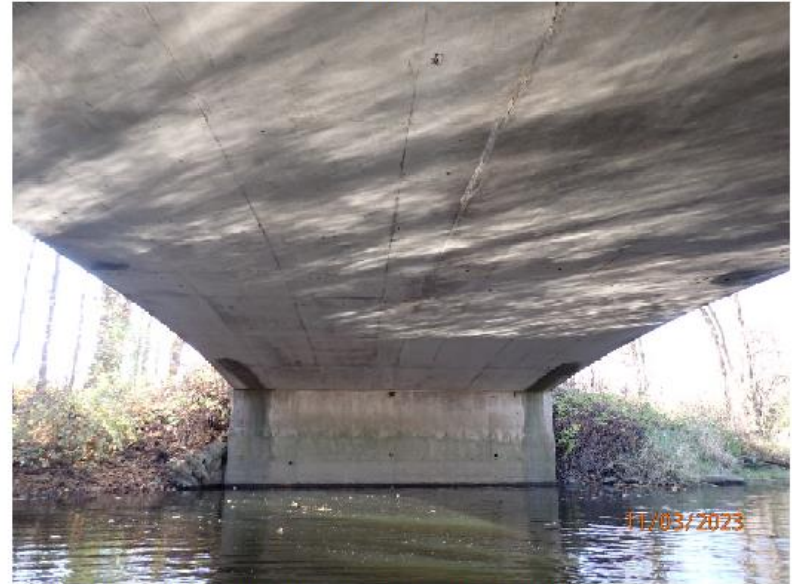
The bridge deck soffit is generally in good condition. There is narrow to medium width vertical cracking with efflorescent staining along the centre of the soffit extending to the abutment sidewalls. The 2022 condition survey noted delamination in the soffit along the centreline and at the deck drain locations. The deck drains appear to be cored through the bridge deck. There is water staining on the bridge deck soffit at all four deck drains. The concrete abutments are generally in good condition with light scour at the waterline and isolated narrow vertical cracks. The concrete wingwalls are generally in good condition. There is light erosion at all four corners.

Photograph No. 3: 0442: Underside of the structure looking south.

Following the results of the 2022 condition survey, we recommend rehabilitating the structure NOW. The rehabilitation work includes the following: concrete patch repairs, waterproofing and paving the bridge deck, replace steel barrier railings and posts with concrete parapet walls, and replacing the deck drains.

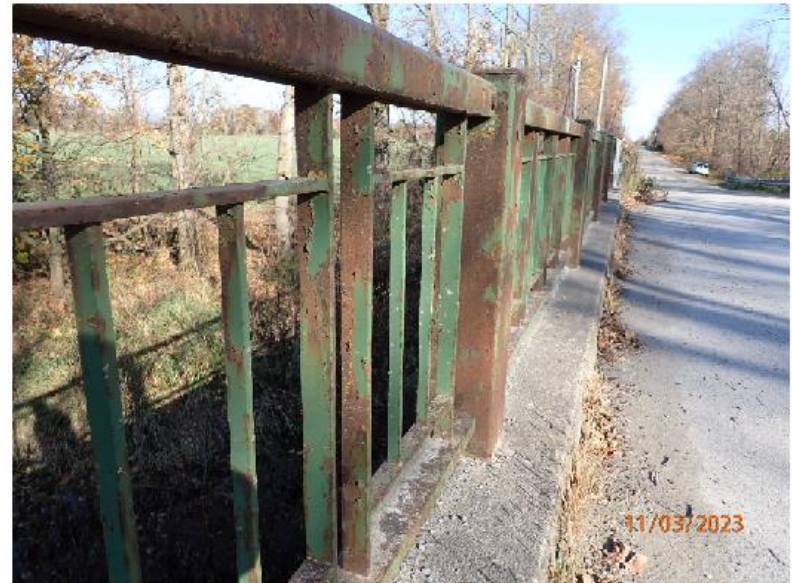
Photograph No. 4: 0418: Corrosion in railing (typ).
