Stormwater Pond Assessment Township of West Lincoln

August 12th, 2024

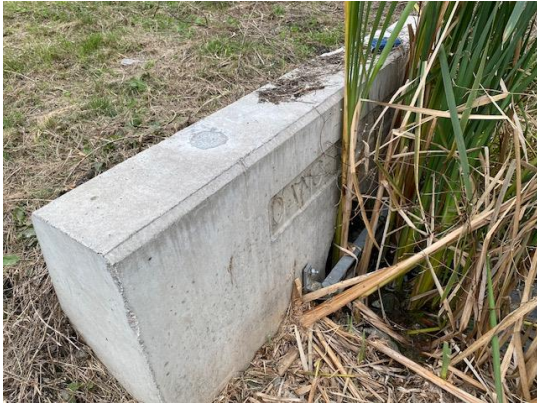
Dennis Dr SWMP

- Condition Assessment:
 - 5 ponds with minor condition issues (i.e. remove vegetation/trees, remove phragmites, install gate lock)
 - 1 pond (Riverview Estates) with minor facility improvements that Township's Operations Department could address
 - Costs for repair included in capital costs for cleanout
